artisJet proV6

Trouble Shooting for Software

2020

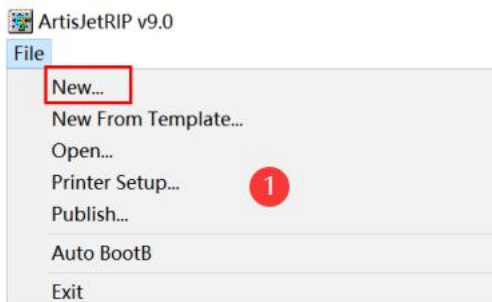
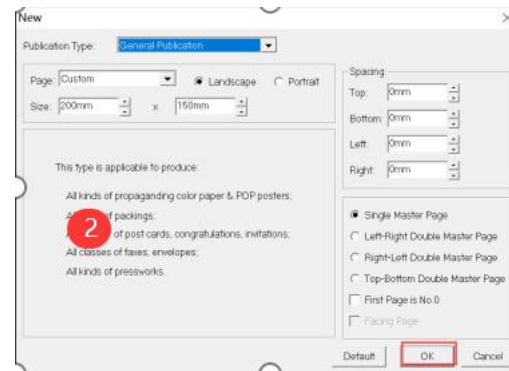
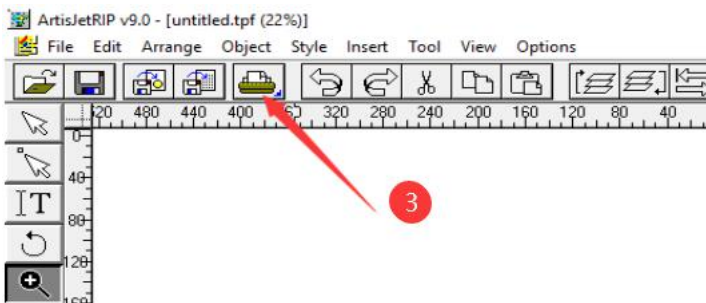
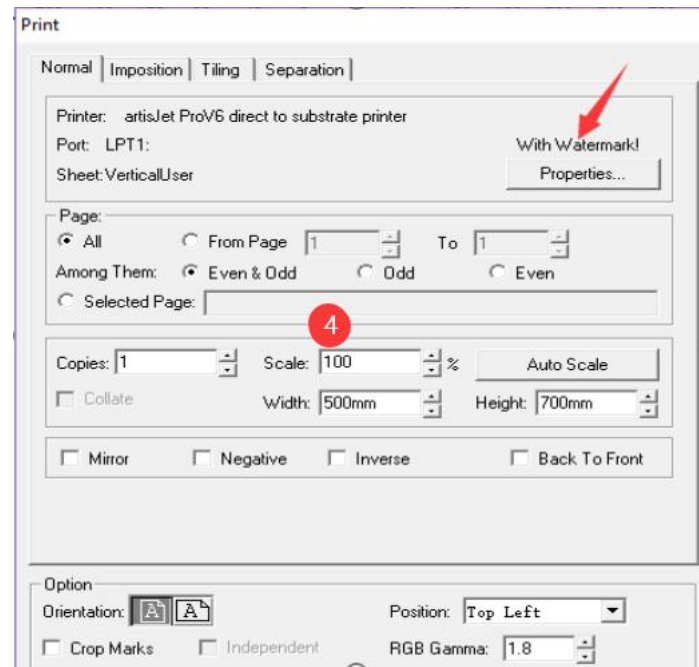
2 Why isn't there a task progress bar in the design software(RIP) when the task is sent.

Click the printer icon from the design software (Rip V9) to see if there is “with watermark”.

Click File-->New to make new page size.

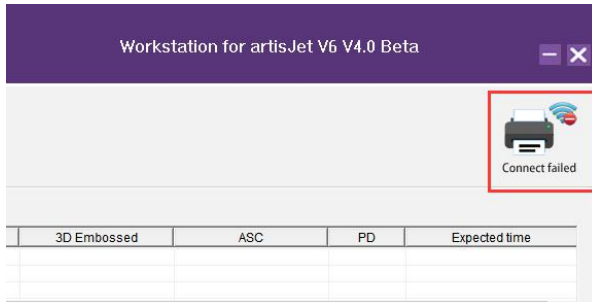
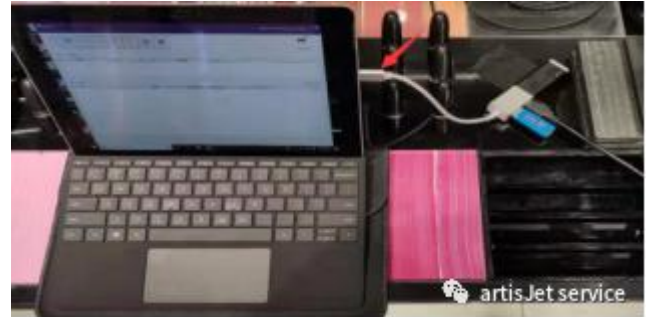
What to do when the icon in the upper right corner of Workstation shows connect failed?

Reseat the USB extender or USB cable.
